## **PLDA Questions to NBU Board of Trustees on June 25, 2026**

### **Answers Provided by Mark Steelman, NBU COO on July 24, 2026**

WASTEWATER  
VULNERABILITY STUDY

## New Braunfels Utilities

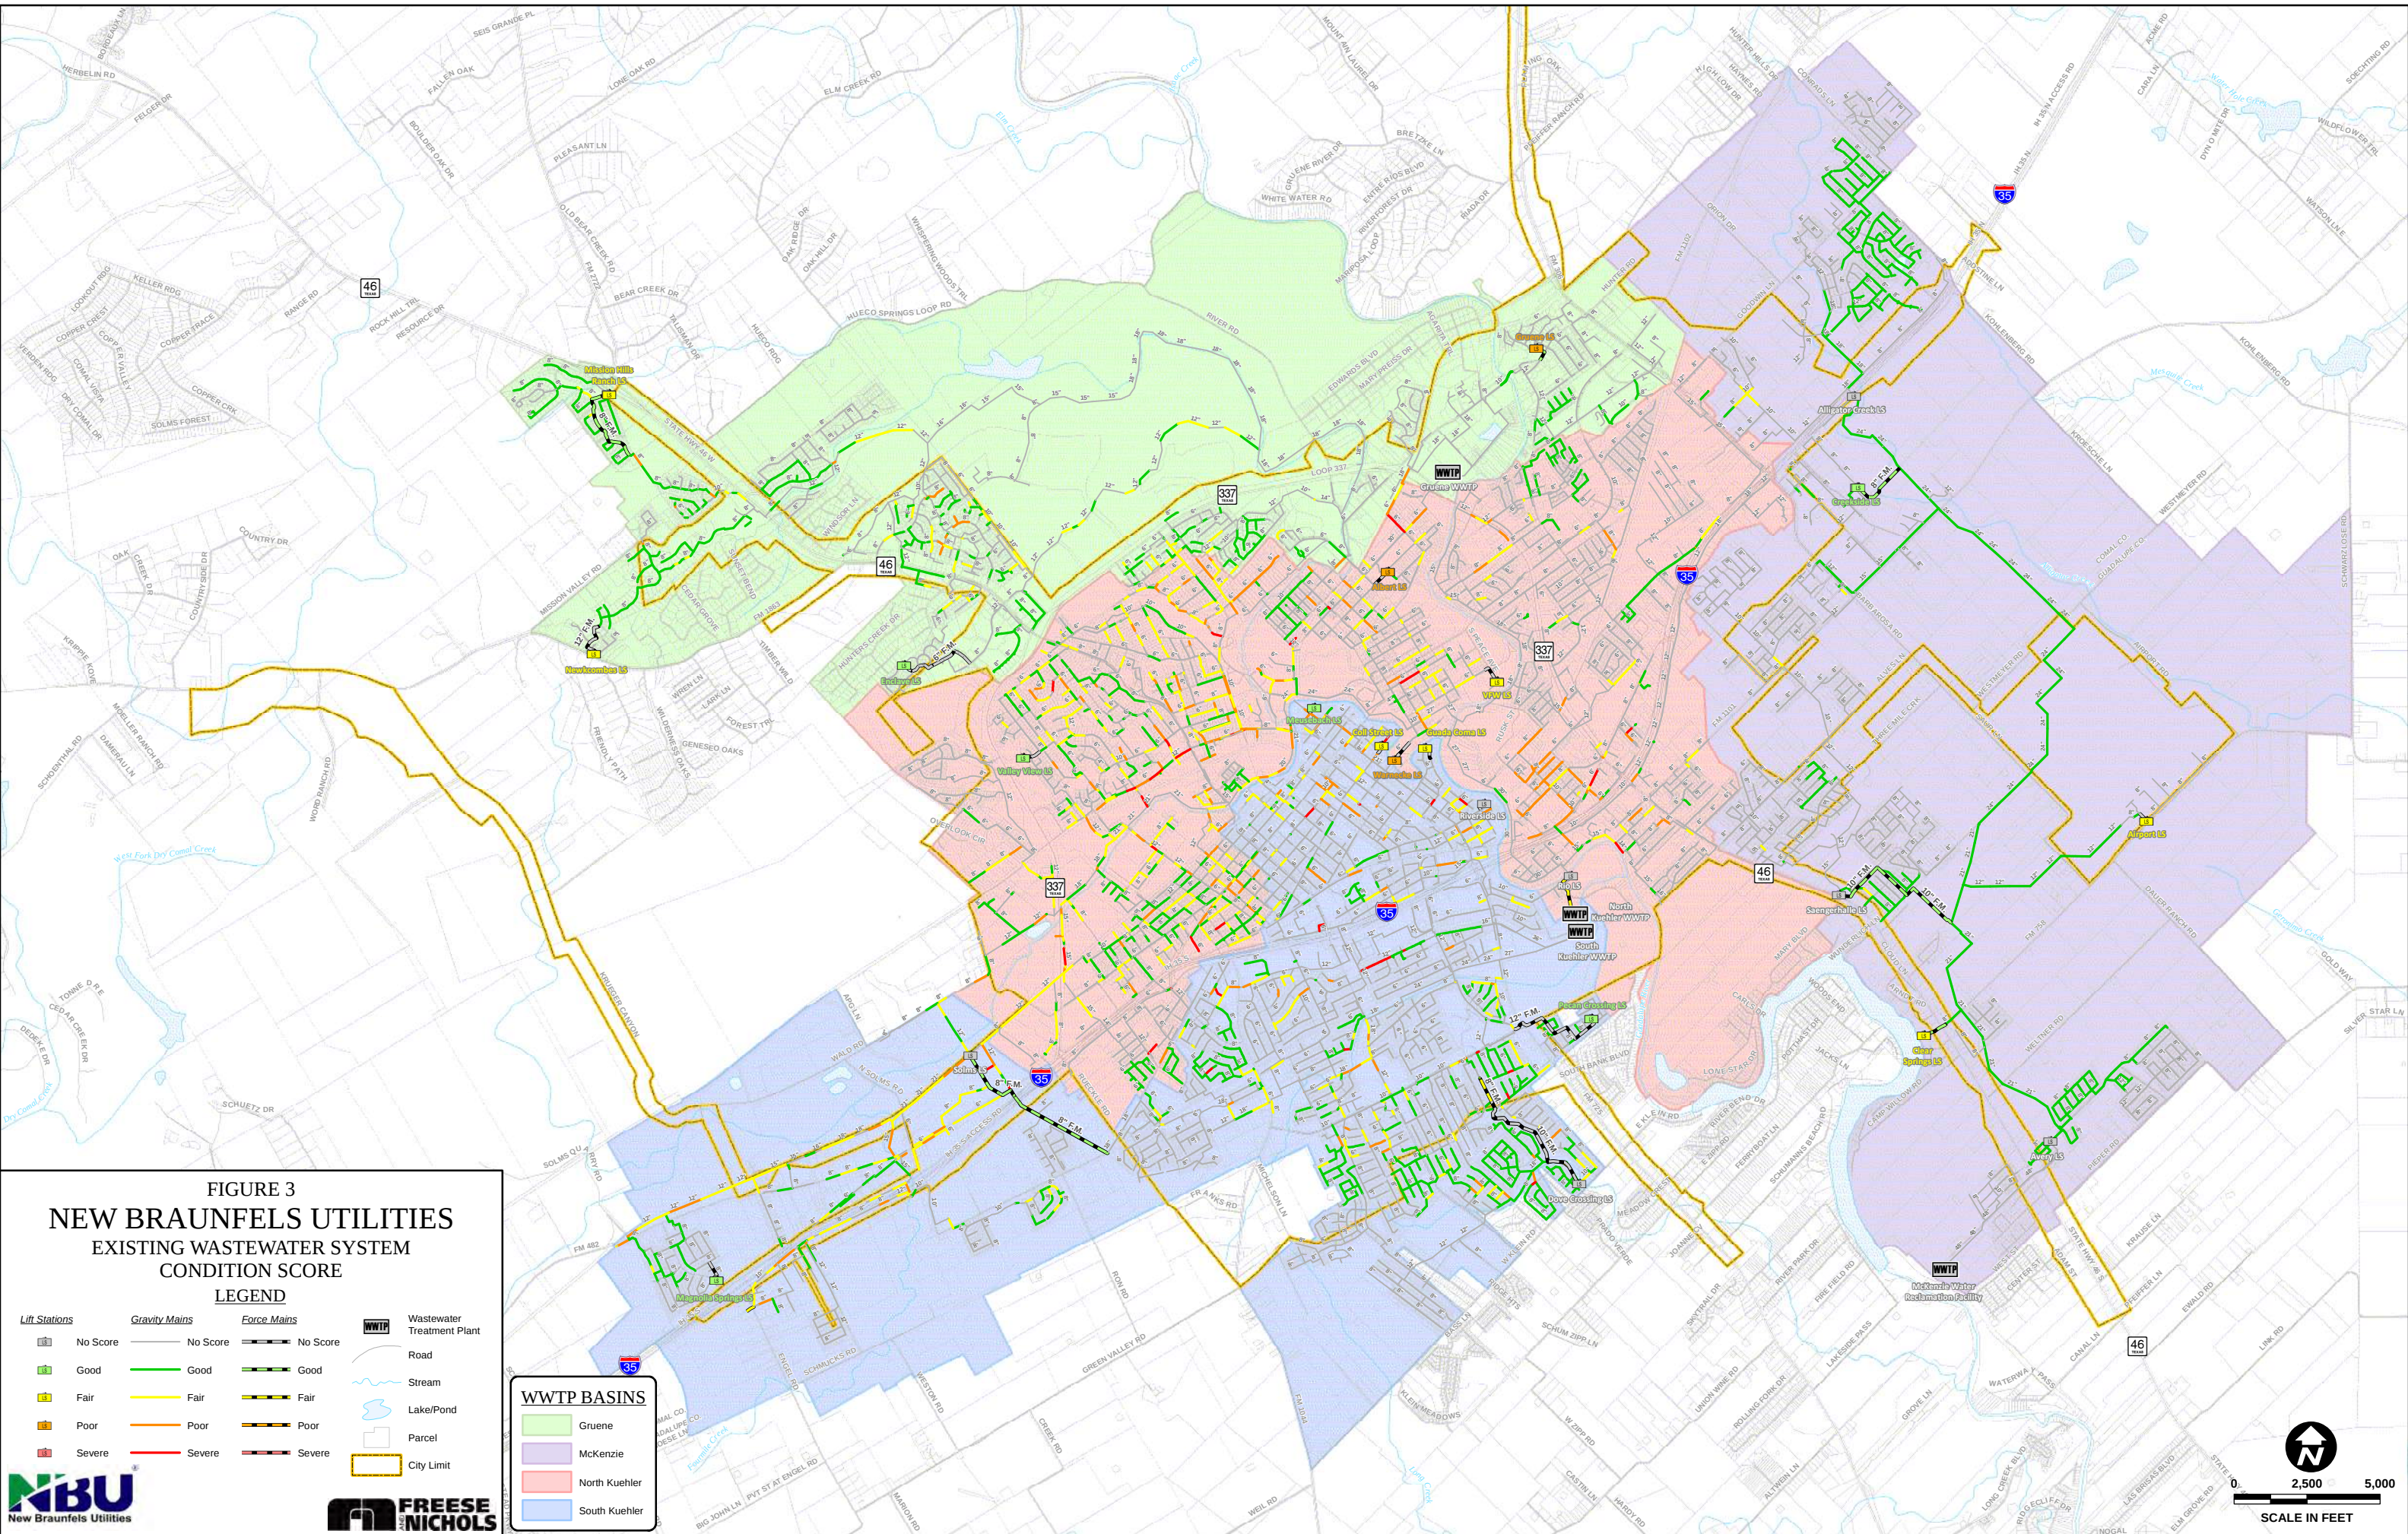
FIGURE 3  
NEW BRAUNFELS UTILITIES  
EXISTING WASTEWATER SYSTEM  
CONDITION SCORE

Condition scores are calculated for each asset by multiplying individual parameter scores by a weighting factor and totaling the weighted scores for each parameter. Condition scores are then grouped into ranges, and qualitative scores of “Good” to “Severe” condition are assigned. Parameters and scoring criteria for each asset type are described in the previous sections. Results of the condition assessment for all asset types are shown on **Figure 3**. Detailed condition scoring results for gravity mains and force mains are shown in **Tables 9, 10, and 11**.

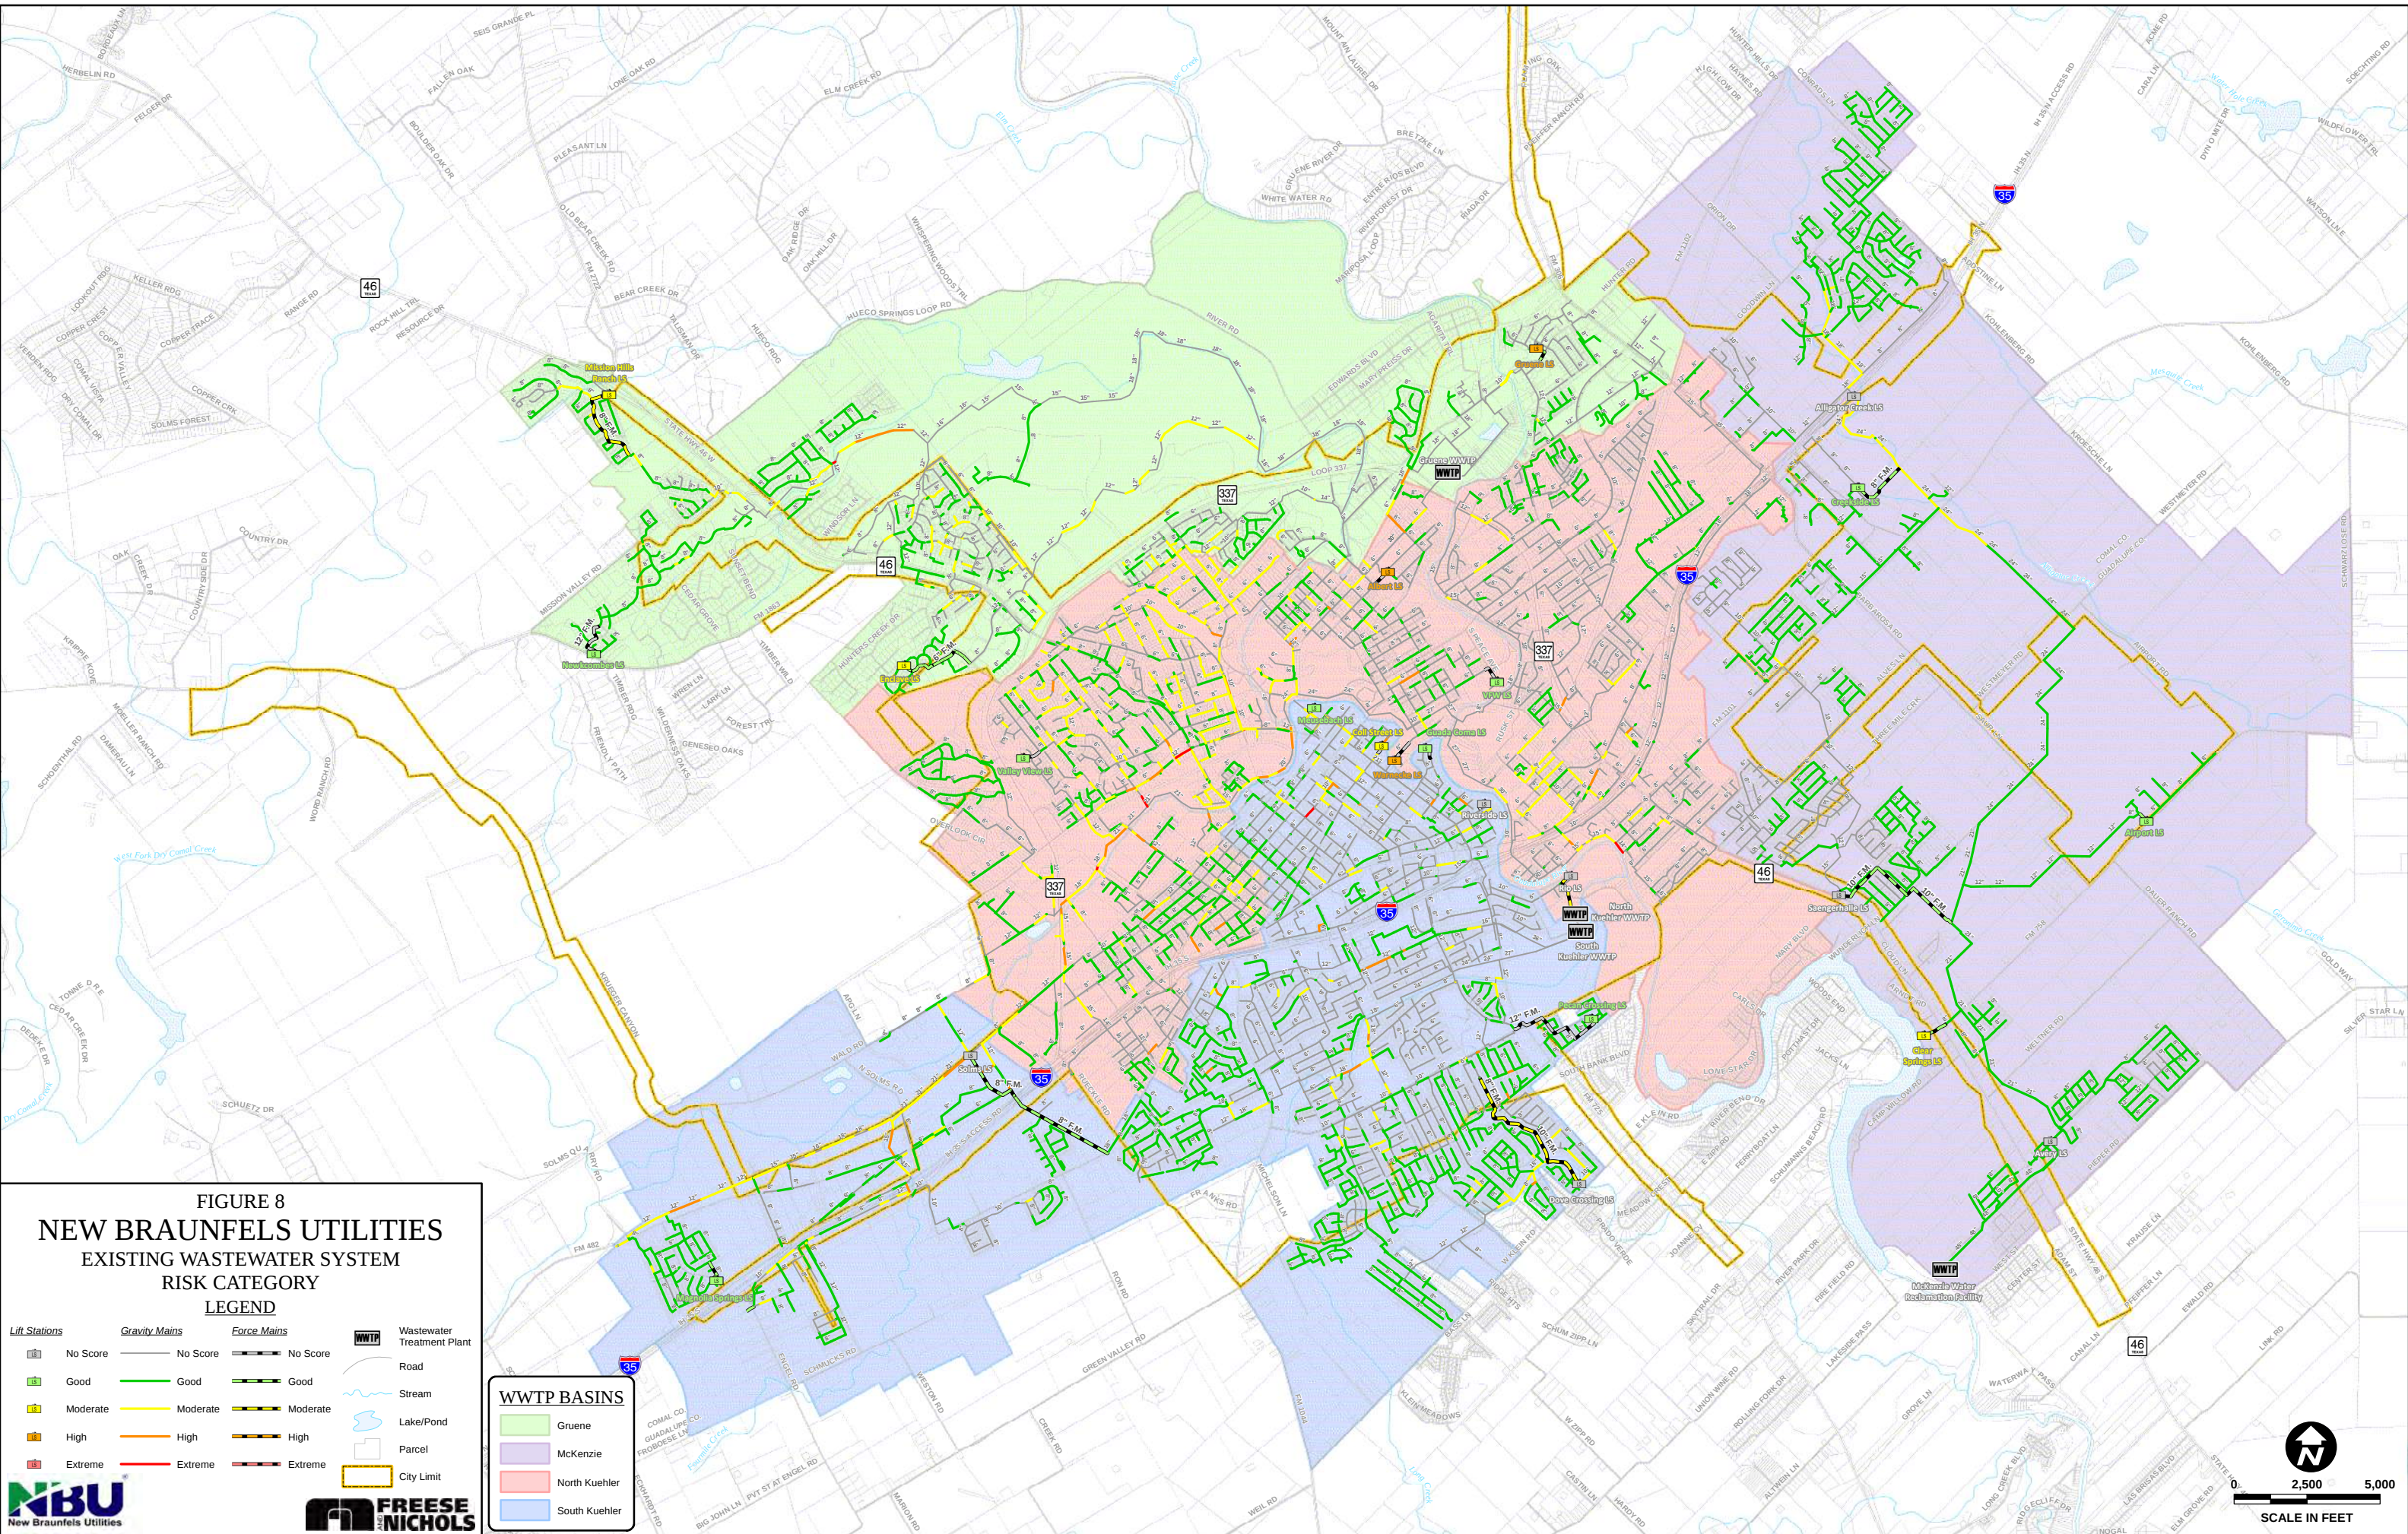
FIGURE 8  
NEW BRAUNFELS UTILITIES  
EXISTING WASTEWATER SYSTEM  
RISK CATEGORY  
LEGEND

Results of the wastewater collection system RBA are shown on **Figure 8**. The symbology on **Figure 8** corresponds to the risk levels presented in the risk matrices. The results of the risk based assessment indicate that the majority of the evaluated system is in good or fair condition with just over 1% of the linear assets identified to be high or extreme risk. Generally, the newer areas of the system have less risk, with no high or extreme assets in the McKenzie WWTP basin. The majority of assets identified to have high or extreme risk are within the North and South Kuehler WWTP basins and inside of the State Highway 337 Loop. The results of the risk based assessment facilitated the development of the prioritized renewal CIP discussed in the following section.
